PW/Utilities Connection

November 2005

Department deals with Hurricane Wilma issues in aftermath

Stormwater pipe caves in under Croton Road

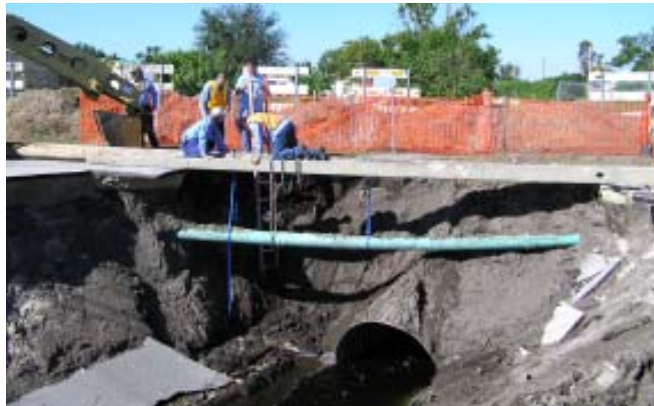
By Tuesday, the hole had gotten even larger, growing to about 40 feet. Not only had the road collapsed above the stormwater pipe, but there was also a sewer line hanging precariously above that pipe. A pole was placed across the hole and chains and straps were used to hold up the sewer pipe. As the hole grew, a larger 40-foot pole was needed to replace the smaller one.

The 72-inch stormwater pipe that failed was made of corrugated metal and had corroded due to soils and water flowing through it over the years.

"The problem was when the large volume of water was pushing through, it started leaking out of the joints and caused the line to cave in from the bottom," Giorgio said.

At the south end of Croton Road, crews from Wastewater Collections and Streets & Stormwater attach sewer pipe to a pole. Gator Hembree and Matt Simon are on top of pole, while Larry Blumenburg, Butch Burke and Josh Baker assist.

"The City is currently getting quotes from contractors to replace the 160-foot run of pipe," said Superintendent Bill Williams. "The work should be completed in approximately 60 days, depending on the availability of pipe and when the contractor can get in."

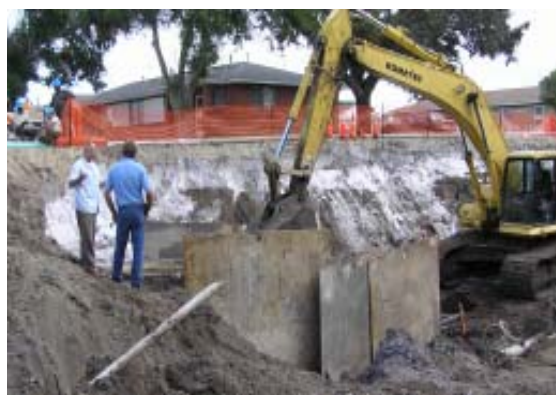
In the south end of the City, another pipe failure occurred thanks to Hurricane Wilma. This break was in a wastewater line underneath Leonard Weaver Boulevard just north of Reddick Street. The road started sinking in due to the excessive weight of the water that ran through the ground from the large drainage canal which is adjacent to the line.

"This pipe didn't break from corrosion, but had cracked from age and stress," explained Utilities Operations Superintendent Tom Hogeland.

Superintendent Tom Hogeland (l) discusses the sewer line replacement project with Bruce Robinson, foreman for Derrico Construction.

A section of the clay pipe, which is about 50 years old, had been scheduled to be lined this fiscal year but instead is now being replaced.

The City has contracted with Derrico Construction to dig some 25 feet under the ground to get to the damaged 27-inch pipe.

It will be replaced with approximately 100 feet of 30-inch PVC pipe.

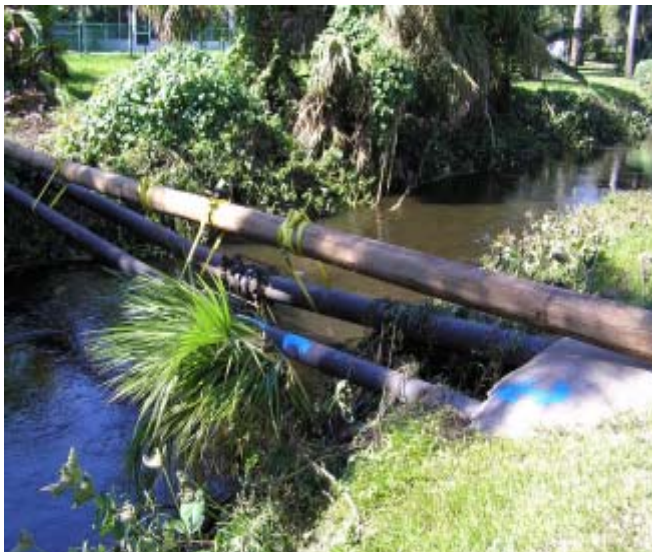
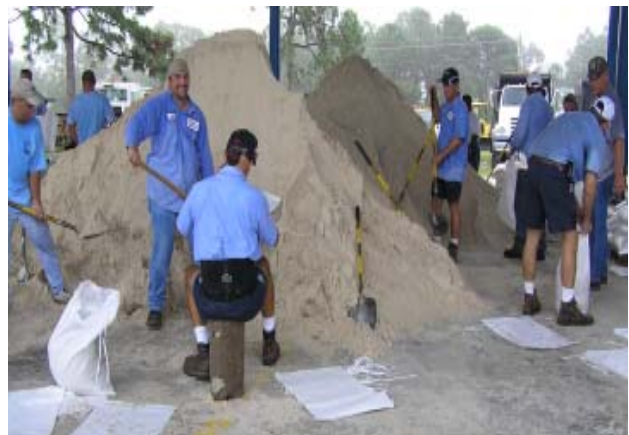
Overflow on County Club

In the picture below, straps are attached to a log placed across Crane Creek just north of Ruffner Road to hold up a six-inch water line and an eight-inch wastewater line. The hurricane caused the canal to overflow, washing large debris against the lines and weakening the supports. The lines will be soon placed under the creek, by way of horizontal directional drilling, to prevent further damage.

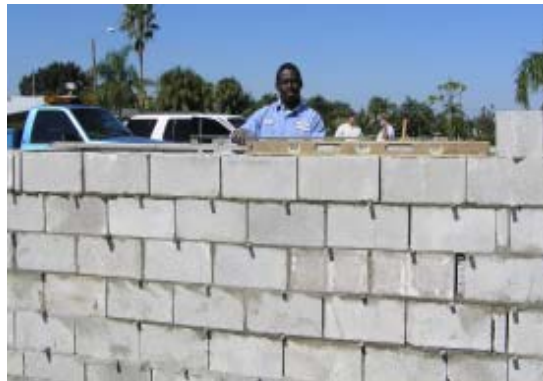
The wastewater line at Florida Tech occurred at the end of a run of approximately 6,000 feet of sewer line installed in the early 1980s. The coating of the pipe had deteriorated, allowing sewer gases to attack the pipe's raw iron.

Even though the pipe was only about 20 years old, the belief is that during the manufacturing process, the coating that was applied had voids that eventually

Manny Parker of the Streets and Stormwater Division works on new dumpster enclosure at Florida Tech. The previous enclosure was demolished during the wastewater line repairs.

allowed the sewer gases to corrode it.

"All the remaining pipe is in basically the same shape but it hasn't caved in yet," said Utilities Operations Superintendent Tom Hogeland. "We plan to line all of it in four different sections to take care of the problem before there are any more breaks."
